Interconnection Evaluation Study Report

**100 MW Wind Generation in
Columbia County, Wisconsin
MISO #G371 (#37921-01)**

Prepared for the Midwest ISO

American Transmission Company, LLC

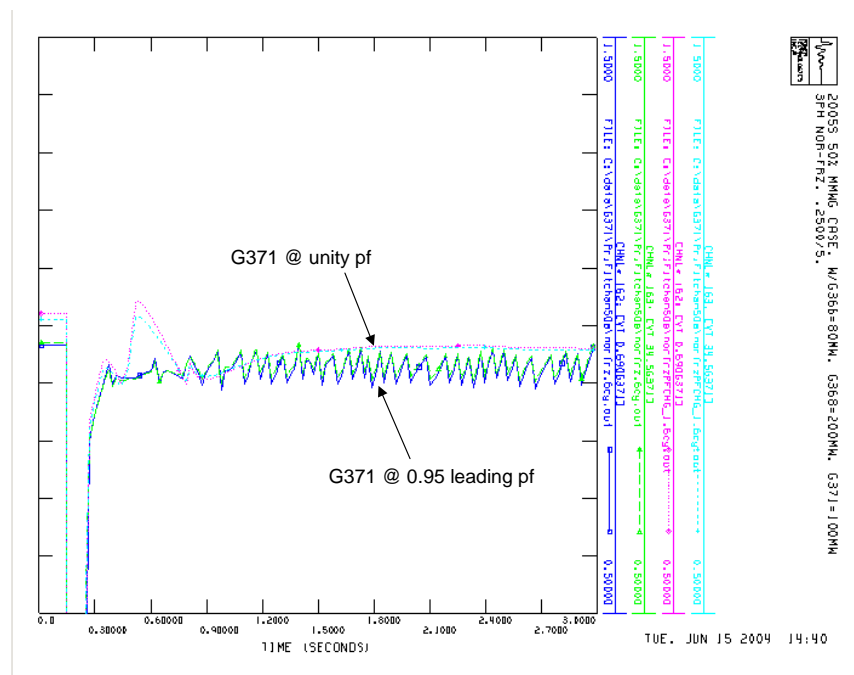
Figure 3.1 – Oscillating Voltage Response of G371 for a Fault on the North Randolph – Friesland 138 kV Line.

The primary contingency results are summarized in Table A.1 in Appendix A. Stability analysis did not identify any angular stability violations for any primary contingencies studied when the G371 generation is at its full capacity of 100 MW. No damping violations were found for any of the primary contingencies studied. However, G371 produced an unacceptable voltage oscillation for contingency #3 (Figure 3.1). An additional simulation was performed with G371 modeled at unity power factor (as seen at the Friesland 138 kV bus point of interconnection). This

simulation (Figure 3.1) demonstrates the potential need for G371 to operate at a power factor ranging from 0.95 lagging (producing VARS) to 1.0 unity. G371 will either have an operating restriction requiring the wind farm to operate at a power factor between 0.95 lagging to 1.0 unity or may be required to install additional compensation (For example, switched capacitors or a STATCOM) to eliminate the voltage oscillations. The customer should review this oscillatory behavior with the manufacturer to determine if this may solely be a modeling issue.
