**Generator Interconnection Study**  
**System Impact Report For GIC027**  
**(MISO #G093 / #37004-01)**  
**Revision 1**

**December 6, 2002**

**American Transmission Company, LLC**

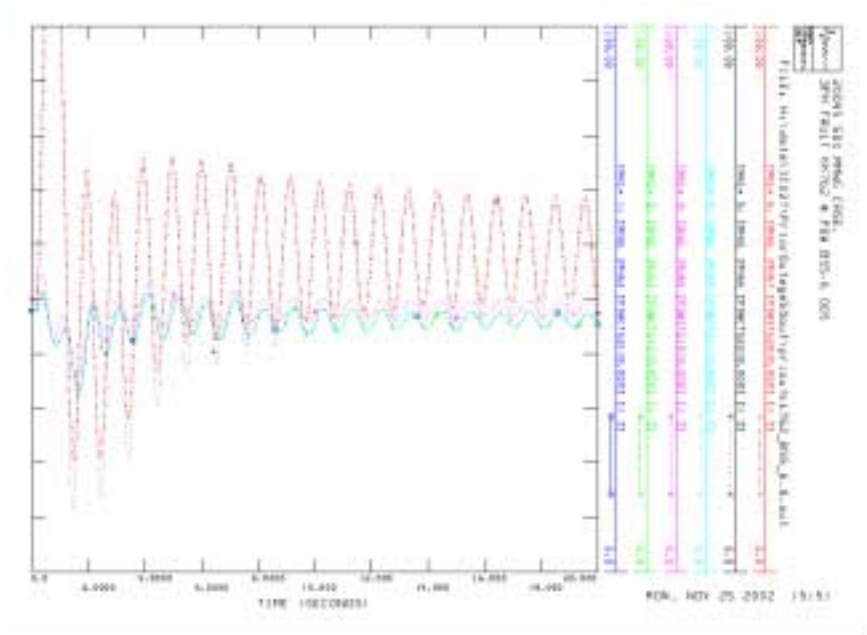
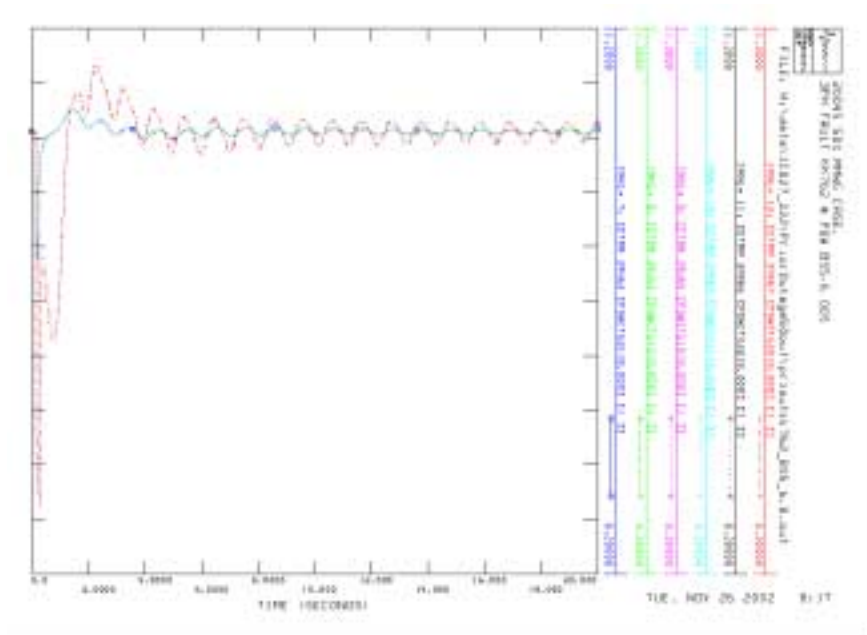
Figure II.1 Damping for Contingency F5a (Original Connection)

Once critical clearing times were found, additional simulations were performed to identify any possible damping concerns with the proposed generators. Each contingency was performed and the disturbance was removed at the found critical time. The behavior of the generators was then monitored to 20 seconds to verify that all oscillations damp out and the system returns to normal. All generators showed acceptable damping after the disturbance is removed from the system, with the exception of prior outage contingency #F5a (Figure II.1). Damping for this contingency is considered to be unacceptable and additional study work will be required for this contingency. Use of power system stabilizers, possible generator reductions, bus reconfigurations, and additional transmission support may be necessary to obtain acceptable generator damping for this contingency.

(Angle)

(Voltage)

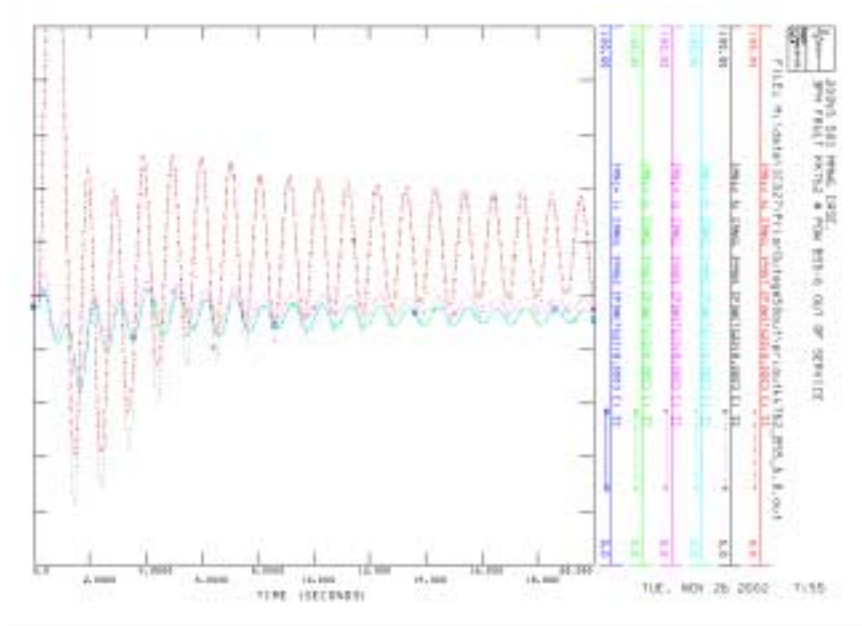
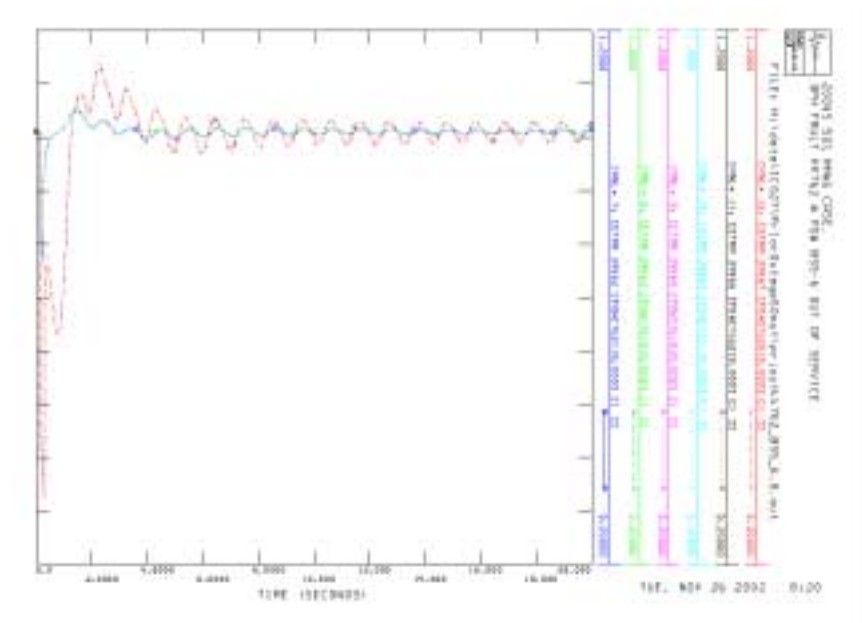
**Figure II.2 Damping for Contingency F5a (Alternate Connection)**

Once critical clearing times were found, additional simulations were performed to identify any possible damping concerns with the proposed generators. Each contingency was performed and the disturbance was removed at the found critical time. The behavior of the generators was then monitored to 20 seconds to verify that all oscillations damp out and the system returns to normal.

(Angle)

(Voltage)
